Arboricultural Assessment for Point Lonsdale Playground Point Lonsdale Victoria

14th February 2011

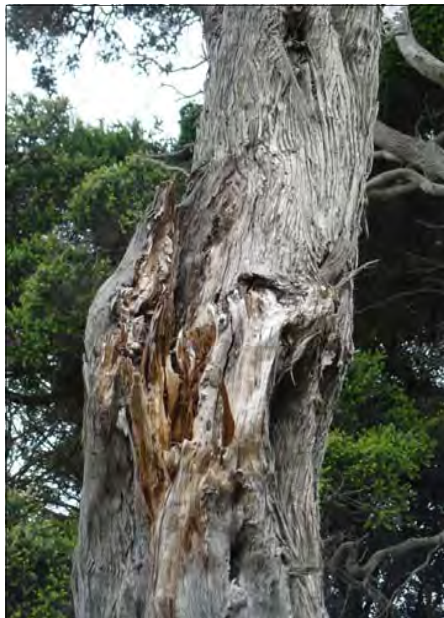
This Moonah consists of twin trunks which originate from ground level, hence the two DBH measurements. The tall and upright trunk was previously bifurcated, although the north-eastern scaffold failed previously and has subsequently left a substantial tear in the trunk fibres at its point of attachment which was approximately 4m above ground level. This failure has also exposed a considerable amount of internal decay.

This specimen has recently suffered the failure of 1/2 of its canopy, and given its location over the top of a highly populated playground, it appears lucky that no-one was injured. The upright trunk has suffered extremely high levels of damage which cannot be appropriately dealt with using modern Arboricultural principles and practices, and as such, poses an unacceptable risk of failure. The trunk supporting the Bracket Fungal Fruiting Bodies is obviously hollow and of major concern, and is likely to fail completely within the next year with potentially fatal consequences. Retaining this tree is not an option, as the level of fungal damage will continue to worsen and cannot be prevented or slowed by any appropriate means. Coppicing the stump could potentially occur to re-establish a new tree quickly.

Trunk damage from the previous branch failure on Tree 196 at 4m.

Remove this tree immediately due to serious health and safety concerns associated with its almost certain failure in the near future.

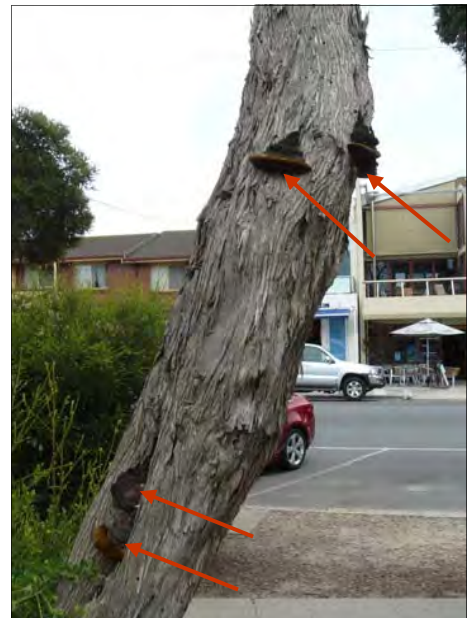
The smaller of the two trunks leans to the north-west on a considerable angle. As can be seen within the photographs at the rear of this report, this trunk is riddled with large and seemingly mature Bracket Fungal Fruiting Bodies which are located between 1-2m above ground level. A simple percussion test performed during the ground based Visual Tree Assessment (VTA) indicated that this trunk is completely hollow, with almost no determinable level of viable tissue remaining in place, apart from the cambium layer which is providing the transport of water and nutrients (and is located directly beneath the bark).

Large numbers of mature Bracket Fungal Fruiting Bodies on Tree 196.

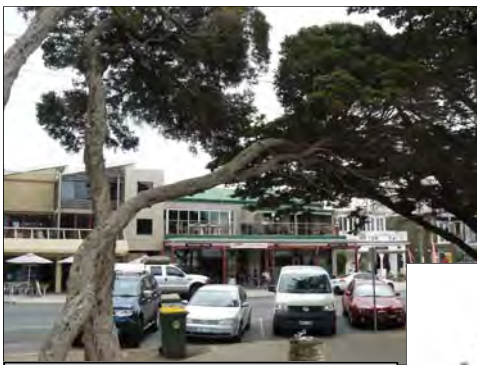
This tree consists of one somewhat narrow central trunk which leans out to the north on a 90° angle as a result of competition for growing space, and phototropism.

It consists of one central trunk which is growing out on a slight angle to the north-west, but then forms into a low growing canopy which is growing on a severe angle (approaching 90°) due to the competition that it has received from Trees 196 and 197.

This tree is growing out on a severe angle to the north, with the fact that the canopy is resting in the neighbouring Monterey Cypress appears to be the only realistic reason why it is still remaining upright. The pressure that the branches are exerting on the Cypress appears to be significant, and the concern is that if these branches were to break, the Moonah would fail and fall to the ground. Once again, this tree is of too high a risk potential to leave within its current situation.

Whilst the trunk system of this tree appears to be relatively sound, the protection it is currently enjoying regarding the presence of Trees 196 and 197 to the south-east means that it has yet to receive the full force of the potentially destructive winds which prevail throughout the area. Given that these two trees will require total removal, as previously described, it is a major concern that the Tree 198 will be left exposed and potentially lacking in the structural protection afforded to it by rubbing on the adjoining trees (and vice-versa).

Trees 197 and 198 in close proximity to the footpath and parking.

Remove this tree immediately due to concerns regarding the angle of departure of the trunk, and of the fact that it will become exposed to increased windthrow potential with the removal of Tree 196.

If trees 196 and 197 are removed, it is recommended that this tree also be removed as it will become exposed to increased windthrow potential, and given the poor structure of the canopy, will be at greater risk of failure onto the carparking area directly adjacent.

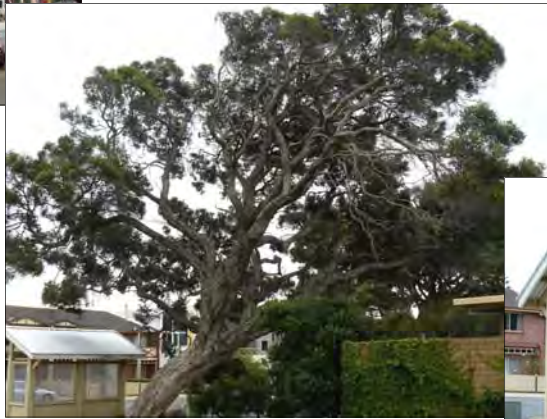
The lower trunk does not support any evidence of basal flaring, with a "telegraph pole" style entry into the soil profile being observed. This soil profile within the planter box arrangement is heavily compacted, and although it once appears to have supported a considerable degree of native grasses, the majority are now dead. The soil profile on the southern side of the tree is also raised slightly, as this is the soil profile opposite the plane of lean. A considerable crack has also been formed within the brickwork on the southern wall of the box, with several of the bricks within the top layer having been dislodged and now being unstable.

The bed in which this tree is located appears to have been constructed within the last 10-15 years, and the soil raised up around the trunk to enable landscaping to occur in regards to the planting of native grasses. This raising of the soil profile is of major concern as it not only smothers the root system in 40cm of soil profile which will limit water, air and nutrient penetration down to the root plate, but it can also lead to trunk collar rot where moist soil is pushed up against the delicate trunk fibres and causes rotting of the outer bark. This moist growth medium is a perfect environs for fungal, disease, and insect growth and proliferation, and will provide a direct path to the structural roots and trunk system which are instrumental in providing the structural support for the tree as a whole. The concern is that even though the trunk and scaffold roots may be rotting away, it will remain invisible to the naked eye until such time as the tree fails.

The planter box has been lifted and cracked, most likely due to the presence of a large scaffold root.

The Moonah within the planter box has several major structural integrity concerns, and a moderate failure potential.

1. Weight reduce the canopy by at least 25-30%.
2. Install an A-framed prop with a wide but V-shaped top-plate underneath the northern scaffold, so as to "catch" the tree if it were to fail, and to allow a visual measurement on whether the tree is leaning over further or is stable. This prop should be made out of strengthened tube which is installed within the ground at an appropriate depth (the exact nature of the engineering required will need to be sourced externally from this report).
3. Monitor this tree every 3 months and react accordingly if changes are observed.

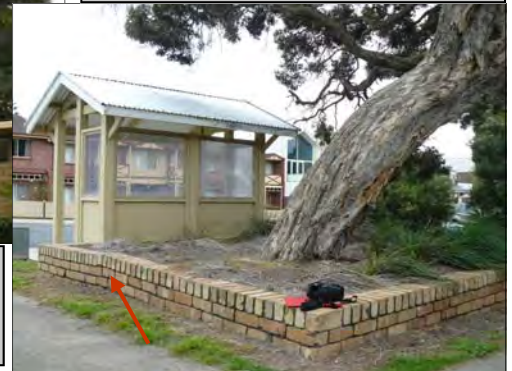
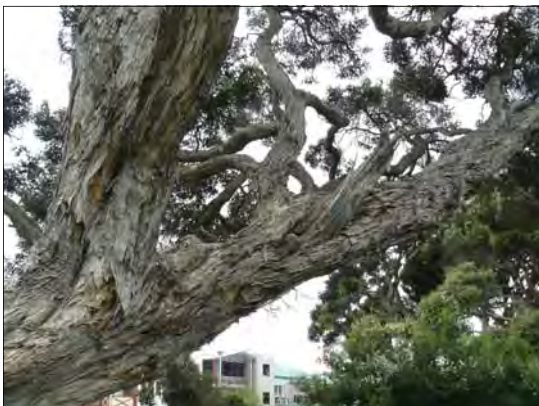
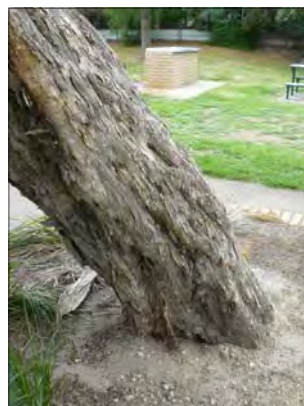
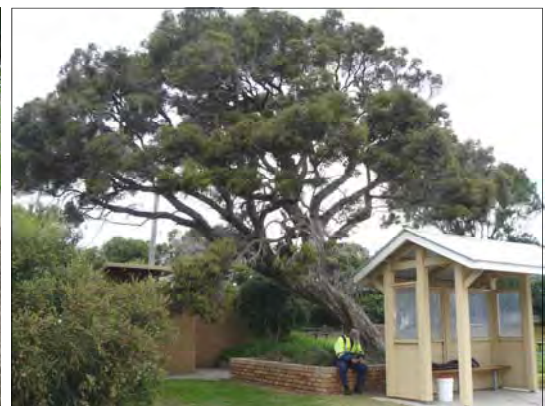
This tree has a thickened single trunk which bends severely to the north, with a slight rotation of the trunk fibres being discovered which indicates that there has been a shifting of the centre of gravity within the canopy.

The north-eastern scaffold has obviously had a sizeable branch fail previously, with a large tear in the branch fibres being present. The discolouration of these branch fibres indicates that this failure is likely to have occurred several years ago.

In terms of the canopy, the most pressing issue relating to potential failure surrounds the wound on the north-eastern scaffold which originated from the previous branch failure. It currently appears that the wound includes a considerable amount of fractured branch tissue, as well as internalised decay both above and below the point of failure. Given that it is leaning out over the toilet block, and therefore has a high "target" rating, its failure would almost certainly cause substantial damage, injury, or worse.

This impressive Moonah has had previous branch failures, an excessive lean, and a relatively limited Safe Useful Life Expectancy, but is a valuable tree and an imposing sight in this section of the reserve.

Although the only way to completely reduce the risk associated with the high target rating and moderate failure potential that this tree possesses at the present time is to remove that tree outright, its seeming value to the area dictates that several other options could potentially be used to reduce the risks associated with its failure in a hope of retaining this tree in the short term. It should be noted, however, that no matter what steps are taken, this tree will continue to be of risk to persons and property, and should not be treated as being totally safe. It also means that determinations will need to be made by the owners of the tree to assess whether the risks are manageable and worthwhile. At the very least, the following will be required: -
